REPORT ON THE HYDROGEOLOGIC INVESTIGATION
OF THE MEADOW PARK LAKE AND DAM
CUMBERLAND COUNTY, TENNESSEE

PELA Project #670101

September 6, 2005

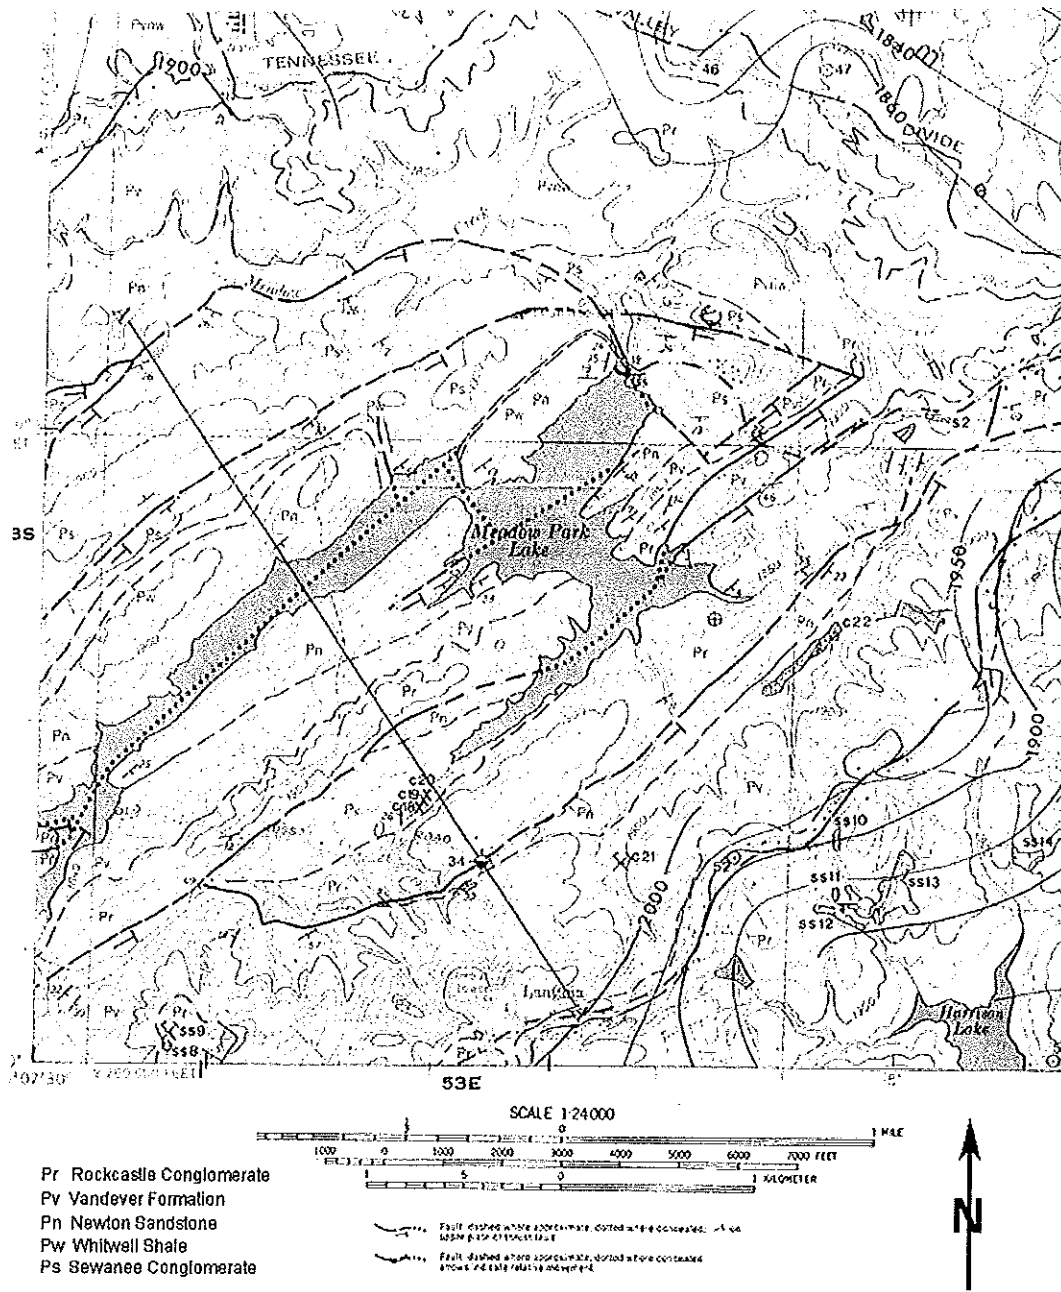
Figure II-2 - Geologic map of the site area.
 Adapted from the Geologic Map of the Crossville Quadrangle, Moore 1981

It is PELA's opinion that the local geology especially the faulting that occurs in the vicinity of the dam, created the unique topographic setting that made installing a dam at that location so attractive. Several faults cross in the vicinity of the current dam. The faulting weakened the bedrock in that area sufficiently that the local stream was able to erode a deep narrow valley rather than a broad flat valley as seen upstream of that location.

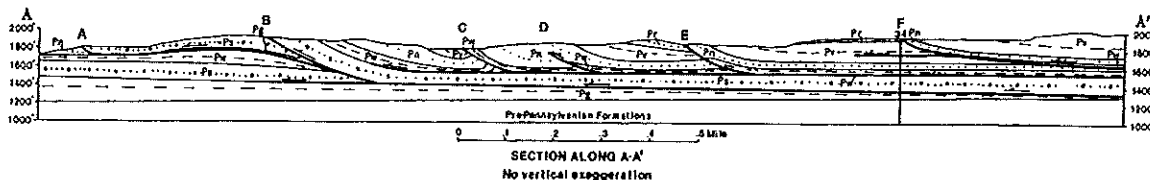
Figure II-3 Cross-section from the geologic map Figure II-2.

The faulting which has occurred across the site could have two potential impacts. If the faults are tight and do not allow groundwater to move along them, the faulting would tend to segment the site and

reduce the potential recharge areas to the lake. This is particularly true on the southeastern side of the lake where the faults cause the bedrock to dip away from the lake. Due to the faulting, shale layers are now almost vertical instead of the normal horizontal layering usually seen in the Cumberland Plateau. The cross section for the Geologic Map of the Crossville Quadrangle shows this very well. However the shallow nature of the aquifers should tend to reduce these impacts. If the faults are open and allow for movement of water along them then ground water may more readily move to the lake. Also due to the faulting it may be possible for water to move from the lake to areas of lower water level, notably below the dam, more rapidly than it would if the bedrock were undisturbed.

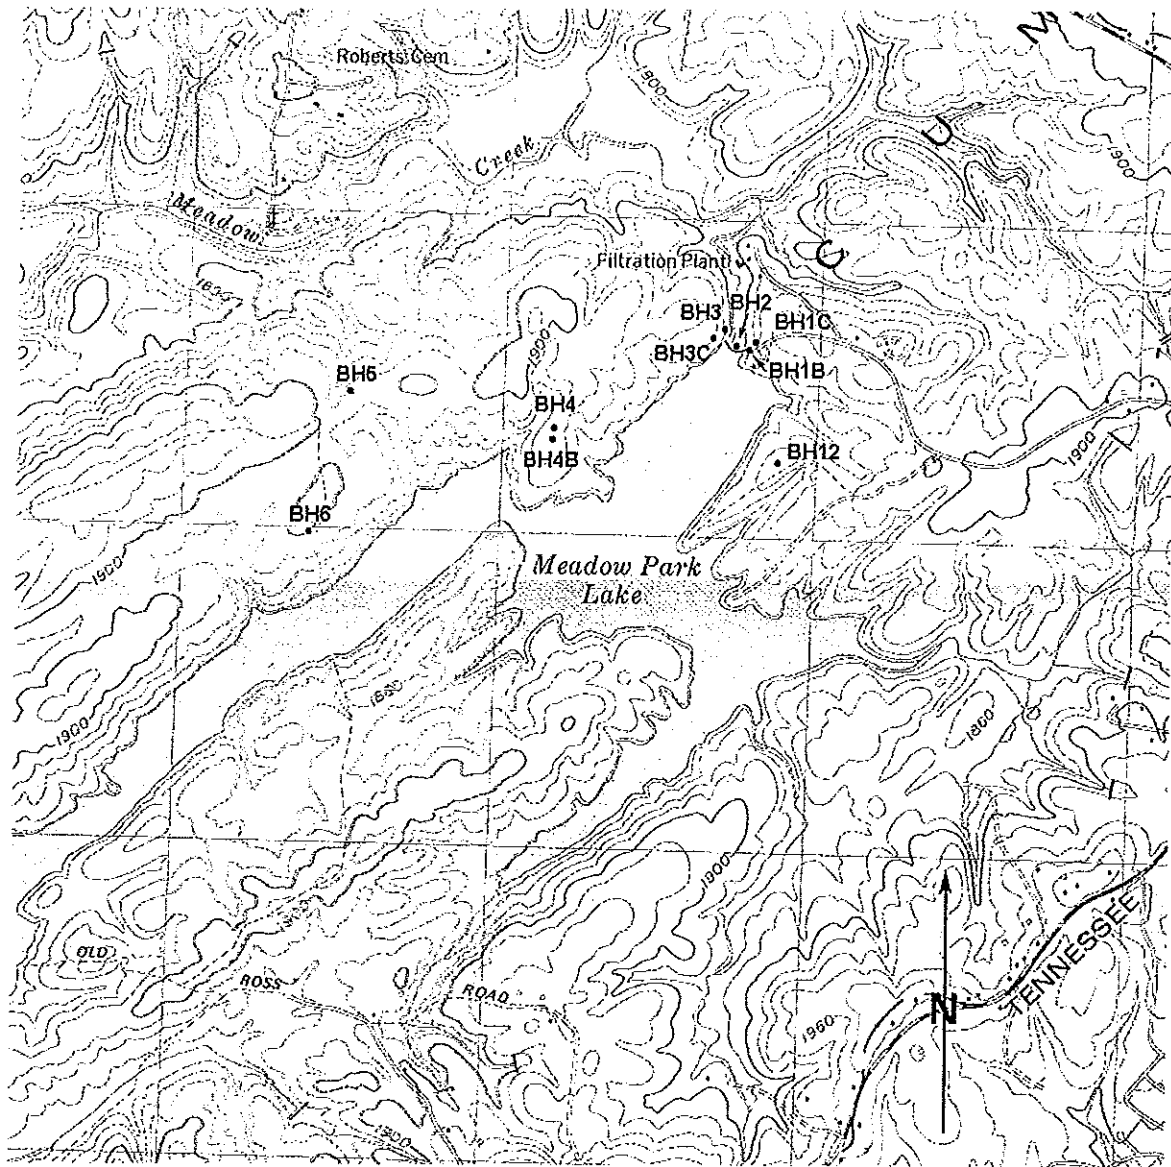
Figure V-1: Portion of the Crossville topographic map showing Meadow Park Lake and the approximate locations of the boreholes.

Boreholes (BH) 1B and 1C are located on the eastern side of the dam approximately 50 feet apart (see figure V-1). The two boreholes showed similar lithologies. BH1B was drilled to a depth of 70 feet below the ground surface (BGS). BH1C was drilled to a depth of 130 feet BGS. According to the geologic quadrangle map these two boreholes should be located in the Sewanee Conglomerate (Ps). The Sewanee Conglomerate is reported to be 140 to 230 feet thick in this area. The samples observed from these boreholes confirmed that they are probably located within the Sewanee Conglomerate. Below the Sewanee Conglomerate is the Gizzard Group, which is predominantly shales. The logs indicate that only sandstones and conglomerates were encountered in the boreholes. The video log of BH3C did not indicate any enlarged fractures or openings. The video logs and core logs showed comparable lithologies.

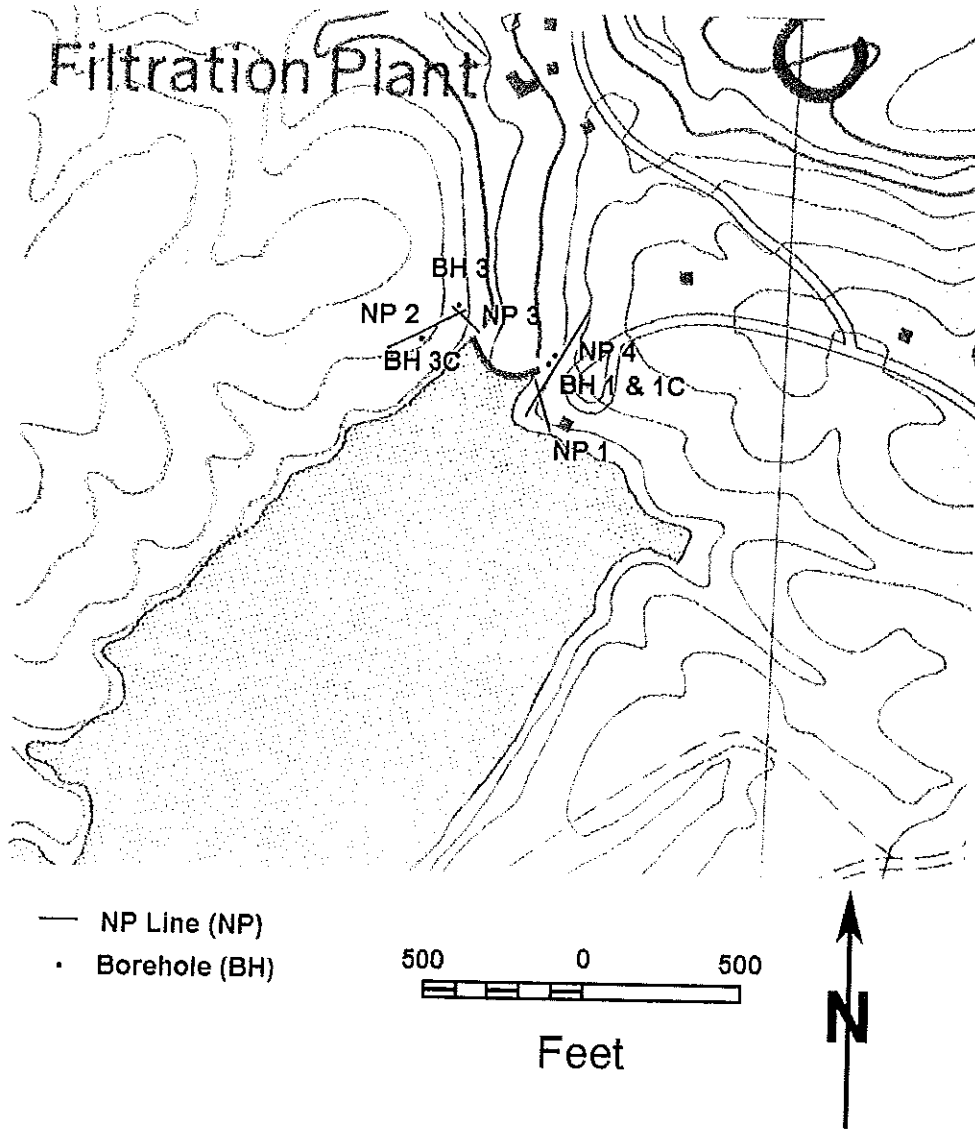
Figure X1: Location map of natural potential transects.

NP transect 1 was located on the east side of the dam and roughly parallel to the dam face (see Figure X1 for map of transect locations). It began near the eastern end of the dam and continued to the waters edge near the boat dock on the lake. Anomalous data was expected and observed where the line crossed a concrete road leading to the boat ramp. The graphical representation of the data on this transect is a relatively smooth graph as opposed to the data obtained on the western side of the dam. The eastern side of the dam has a thicker layer of soil over the bedrock than the western side of the dam.

NP transect 2 was located on the western side of the dam perpendicular to the dam face. This line began near BH3 and extended approximately 60 feet past BH3C. The data for this transect is significantly more erratic than that observed at transect 1. This is probably due to the very thin sandy soil or bare bedrock often exposed. The data indicates a potential anomaly located between 60 and 90 feet with a center at approximately 75 feet. Due to its low magnitude and the erratic nature of the total data set, the data is inconclusive.

NP transect 3 was located on the western side of the dam parallel to the dam face. It began near the end of the dam and extended to a point just beyond BH3. The graph of the data indicates a drop in the voltage due to rise in the elevation from the beginning of the transect to the end. This data is also more erratic than the data from the NP transects on the eastern side of the dam for the reasons given above.

NP transect 4 was located on the east side of the dam and perpendicular to the dam face. It began approximately 230 feet north of the dam and continued to the lake shore, 70 feet south of the dam. The graph of the data indicates an anomalous, negatively charged area. However, with some surface observation, it was discovered the negative spike occurred where the transect passed near an iron water

pipe. The iron pipe draws electrons away from the soil, creating the very negative spike in the graph.

The NP data did not indicate any significant leakage in the abutments to the dam. The data from the east side of the dam was significantly more stable than the data from the western side of the dam. This was probably due to the thicker soil cover in that area. A potential low level anomolous area was seen in the data from line 2. This could be evidence of a "leaking" fault, but due to it's low magnitude and the erratic data in general from this line, this can not be proven conclusively.

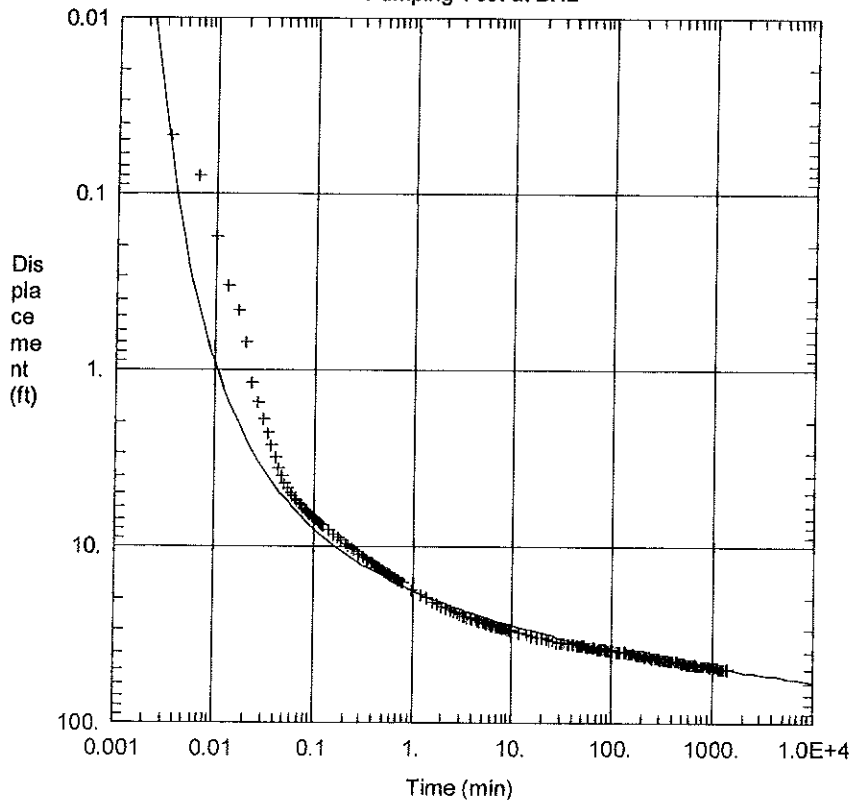
Pumping Test at BH2

At BH2 the pump testing methodology had to be modified slightly due to leakage around the well casing. The sampling pumps used to pump the other boreholes were not capable of pumping sufficient water to significantly lower the water level. A larger submersible pump was tried next. This was able to lower the water level to somewhere near the bottom of the casing. A piezometer (a shallow well in the gravel) had been installed near BH2 to check the amount of leakage between the dam and the bedrock. By monitoring the piezometer it was found that pumping BH2 caused draw down in the water level in the piezometer. This leakage could have been caused by several factors. One possible factor could have been the well casing not being fully sealed into the bedrock which would allow water from above the bedrock to be drawn into the borehole during pumping. Another possibility was an open fracture in the bedrock conducting water from the gravel through the bedrock into the well. To isolate the well casing from the deeper borehole a packer was installed. A packer is a large rubber doughnut that is inserted into the well; the pump and piping passes through the center to the surface. When the packer is inflated it seals and isolates the areas above and below the packer. The packer was installed approximately eight feet below the top of bedrock in the borehole. The video logging showed this area to be very smooth and free of cracks so that the packer would provide a good seal. The pump was installed below the packer and the water line run through the packer casing to the surface. With this configuration, BH2 was successfully pump tested and draw down was not observed in the gravel piezometer. That meant water was being drawn from the bedrock aquifer and was not leaking from the surface gravel.

When pump testing was complete at BH2, the packer was left in place, and a section of clear plastic tubing was attached to the top of the well casing to measure the bedrock water level above the well. The maximum water level recorded was 16.4 feet above the measuring point or approximately 17 feet above the ground surface. This level is below lake level but considerably above the ground surface. It indicates that the aquifer is being affected by the lake, as would be expected, but the low flow rates during testing indicate that there is no direct connection such as an enlarged fracture or joint.

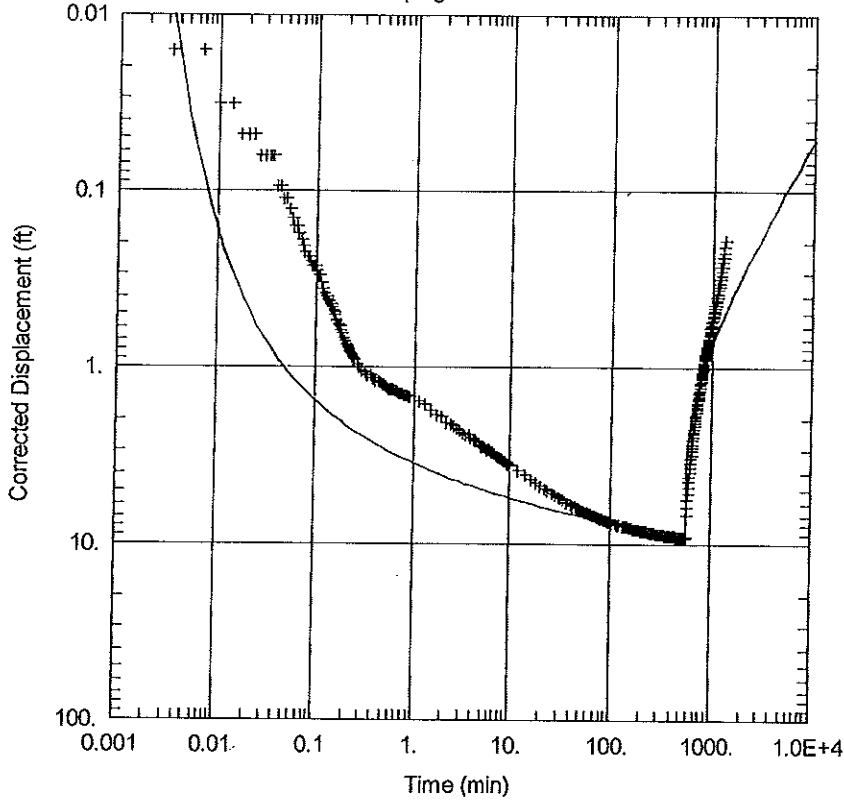
Pumping Test at BH3C

The water-level data indicates potential leakage problems at BH3C at the western abutment of the dam and at BH12 where a significant fault exists. Boreholes located in other areas around the lake show normal hydrologic patterns. No water levels observed in the boreholes indicate a direct, open connection between the borehole and the lake.

Pump testing of the boreholes indicates that groundwater flow rates were very low and were primarily due to the porosity of the bedrock. Movement through fractures is minimal. PELA concludes that the low water levels seen in BH3C and BH12 are due to slightly enhanced groundwater flow associated with faults in these areas, but that the faults are not significant pathways for leakage. The recharge to these faults is through the surrounding bedrock and not directly from the lake. Slug testing indicates that the local geology and hydrology will be similar if the water level in the lake is raised by as much as 20 feet. Leakage should be only slightly greater than what it is now, and should not be a significant problem.
